**The restoration of the Hellenistic fountain of
Sagalassos in Turkey**

THE RESTORATION OF THE HELLENISTIC FOUNTAIN OF SAGALASSOS IN TURKEY

Teresa Cristina Patrício

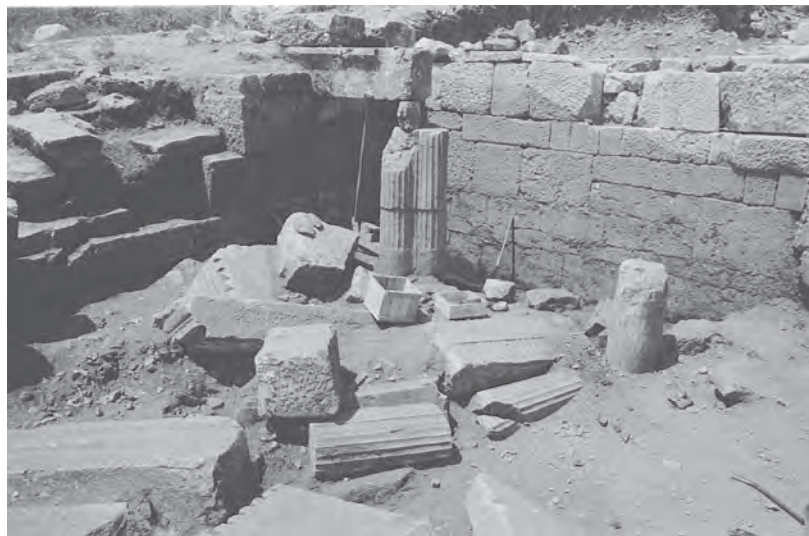
Figure 2 - General view during the excavations, July 1992.

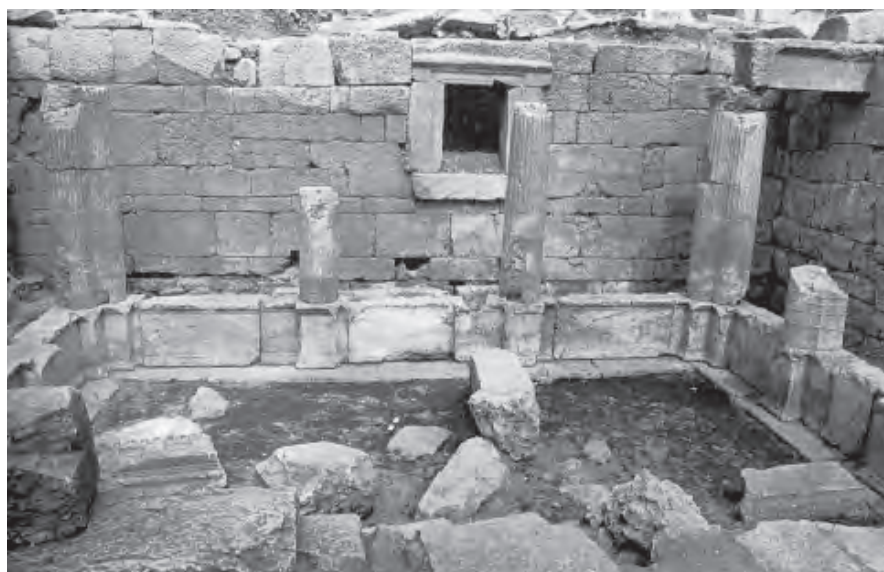
Figure 3 - General view before the restoration works, August 1993.

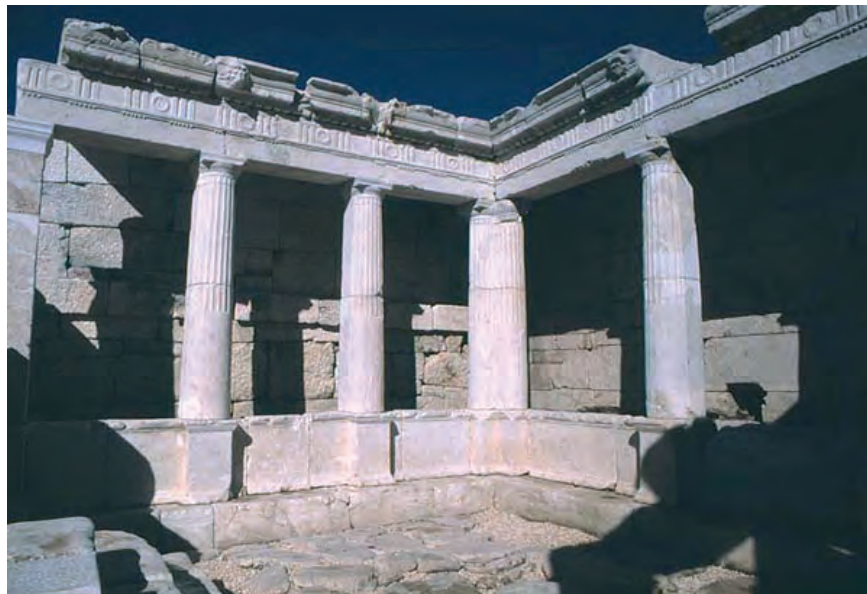
Figure 4 - General view after the restoration works, September 1997.

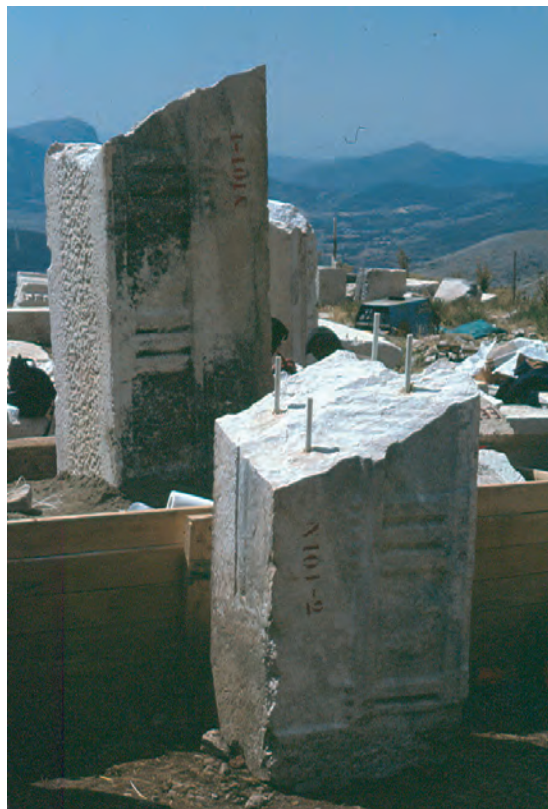
Figure 9 – For joining the architraves, fibreglass rods were used together with the epoxy adhesive.

For joining the structurally important broken blocks, such as columns drums, architraves and cornices, fibreglass rods were used together with the epoxy adhesive. Two conditions were imposed on this work. First, the broken blocks should be joined in such a way that the strength of the joined block would not exceed the limit state strength of the monolithic block. Second, if the joined block were to break, it should break again in the original failure. To fulfil these requirements, the application area of the epoxy glue was limited to only half of the broken surface and the Fibreglas reinforcing rods were designed appropriately according to these considerations. The brittle nature of the fibreglass is an advantage here, as it means that the reconstruction can be altered at any time in the future, as the broken reinforcement can be removed and replaced by a similar system. The number, size and length of the reinforcing rods varied according to the broken parts of the block and its structural function. For the blocks under flexural stress, like architraves and cornices, the rods should have a certain anchorage length, so that they would not be pulled out. Generally 4 fibreglass rods of 34 cm length and 16 mm diameter were used for joining these blocks (Figure 8). Shorter rods are sufficient for joining the column drums, as the main structural stress on them would be in shear. Generally 4 fibreglass rods of 20 cm length and 12 mm diameter were used to join the columns drums.

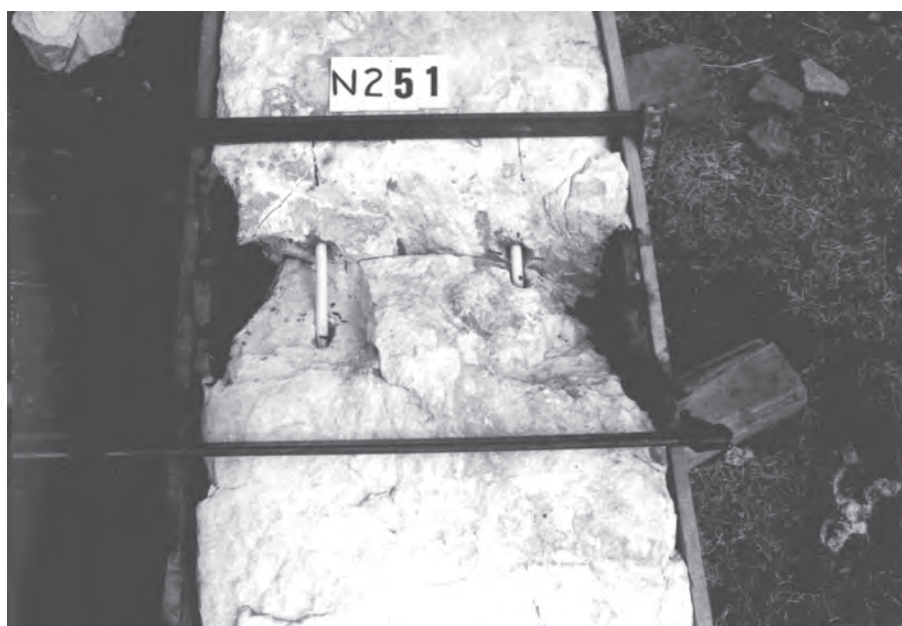
Figure 10 – View of a joined cornice block, before the missing parts were completed.
The fibreglass rods used for joining the two fragments are visible.

The epoxy mortar was applied in a few layers, where each layer was compacted firmly. According to the volume to fill and the structural function of the block to be completed, fibreglass bars were sometimes used for a stronger bond between the epoxy mortar and the stone blocks (Figure 10, Figure 11). As epoxy mortars discolour under ultraviolet radiation and in order to create a proper surface texture, a 1 to 2 cm thick covering mortar was applied over the dried epoxy fillings (Figure 12). The covering mortar was a zinc chloride-based mineral mortar, which was also tested in laboratory before being used. This quick setting and non-shrinking covering mortar has a very similar colour to the stone and its shape and textures can be finished easily by carving (Figure 15).

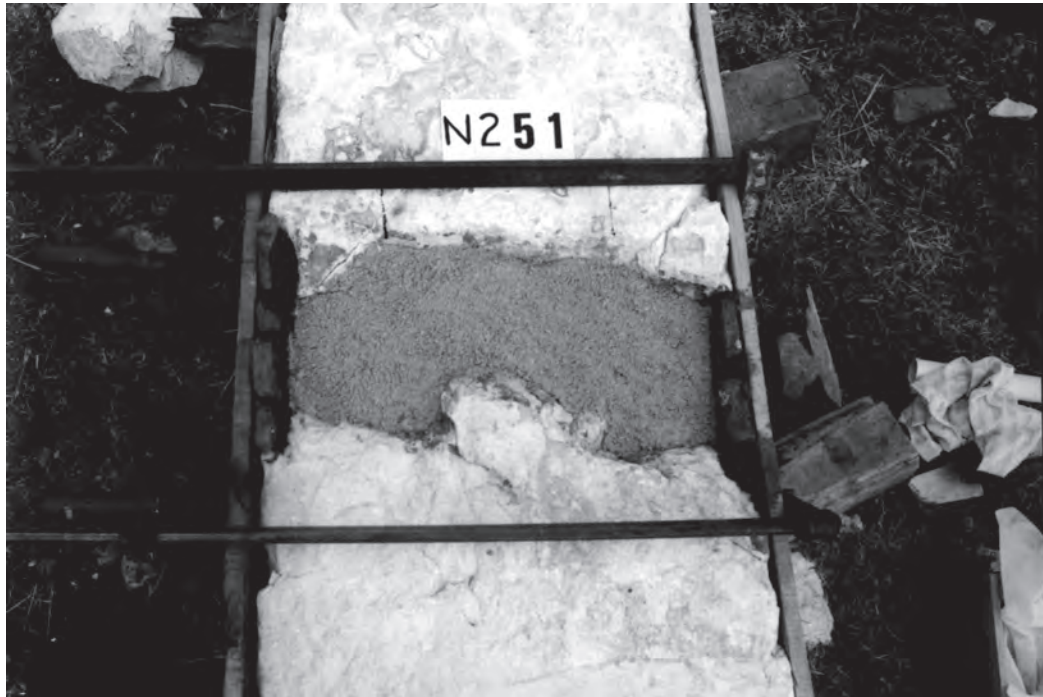
Figure 11 – View of the cornice block after its missing parts were completed by an epoxy mortar.
The epoxy mortar will then be covered by the final covering mortar.

After joining the fragments composing a block, missing parts had to be completed to fulfil the structural integrity. An epoxy mortar obtained by mixing epoxy adhesive with well-graded crushed limestone filler was used for this purpose. The maximum particle size of the filler was 2 mm and the binder to filler ratio of the mortar varied in between 1:5 to 1:8 by volume, according to the application. The epoxy mortar, which was tested earlier in the laboratory, has similar physical properties to the original stone. Its mechanical properties are slightly weaker than the original stone and it also has a more elastic behaviour than the stone.

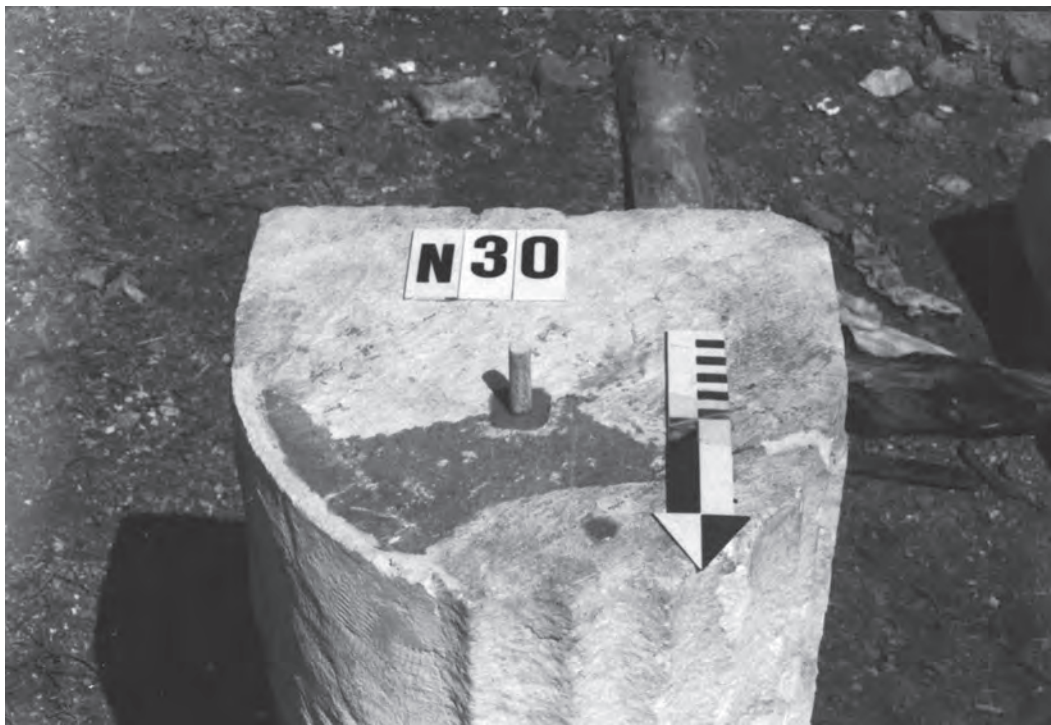
Figure 12 – View of a restored column drum. The filling and the covering mortar are visible
as well as the fibreglass rod for the vertical connexion of the drum.

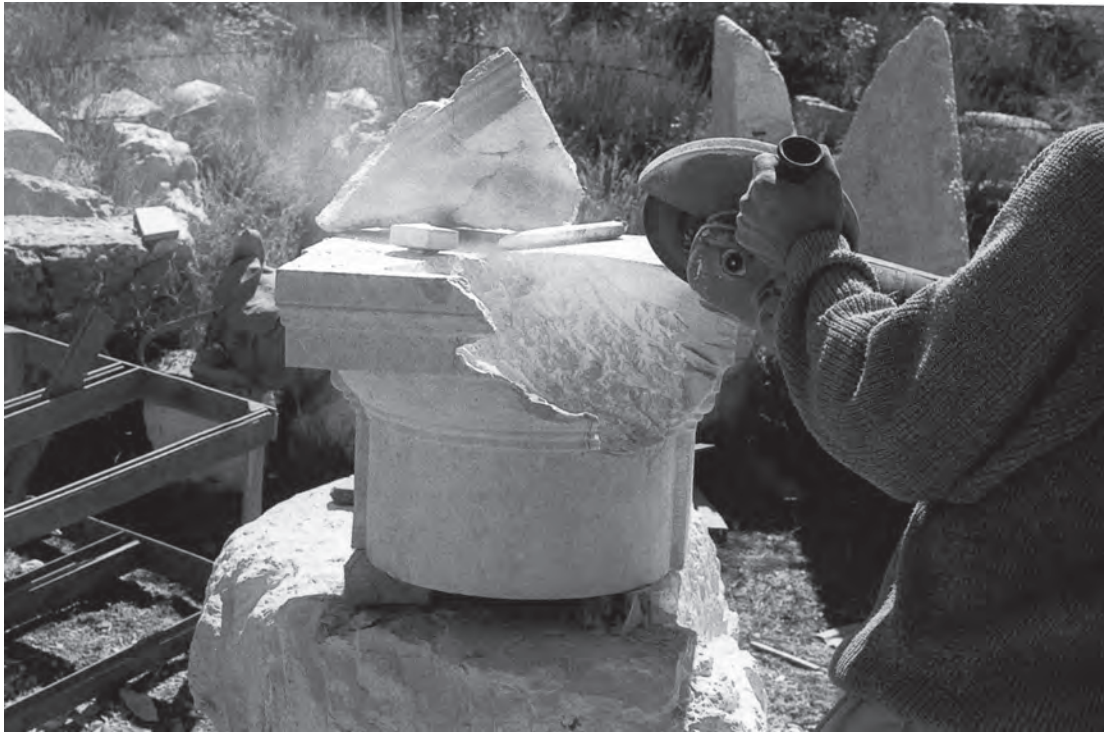
Figure 13 – Preparing a new carved capital for the insertion of the existing fragments from the original capital.

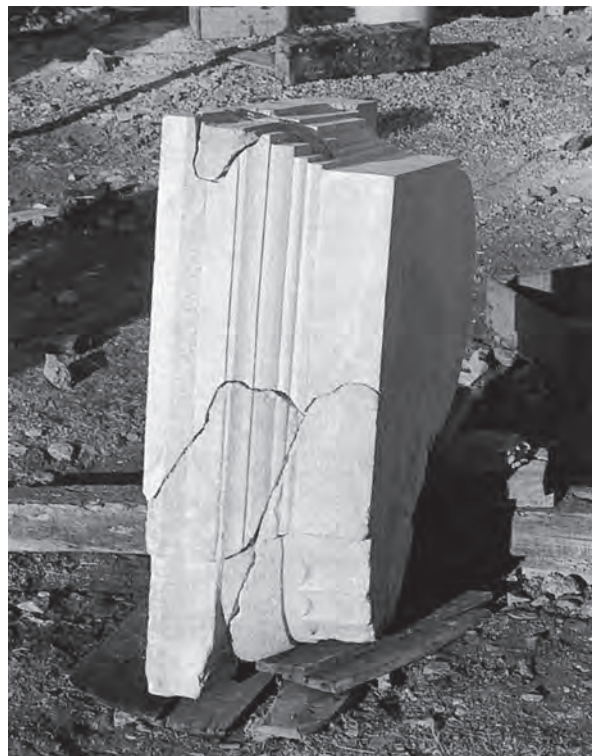
Figure 14 – Insertion of original fragments in a new carved capital.

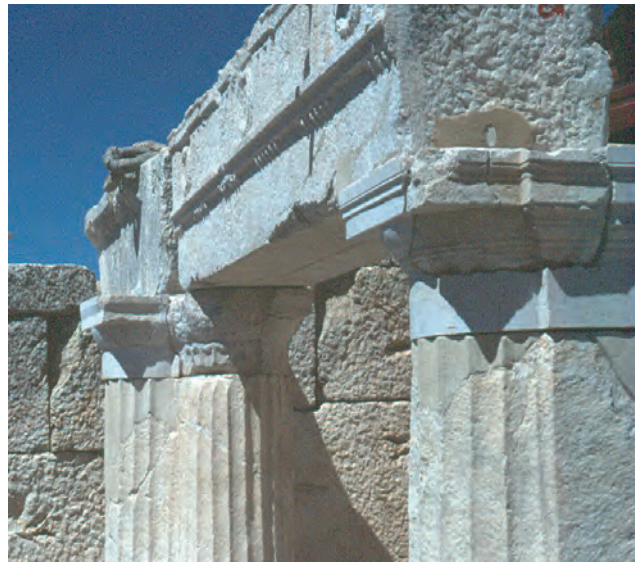
Figure 15 – The original small fragments integrated into the new carved blocks. The final decorations as well as matching the integrated original fragments were further finished.

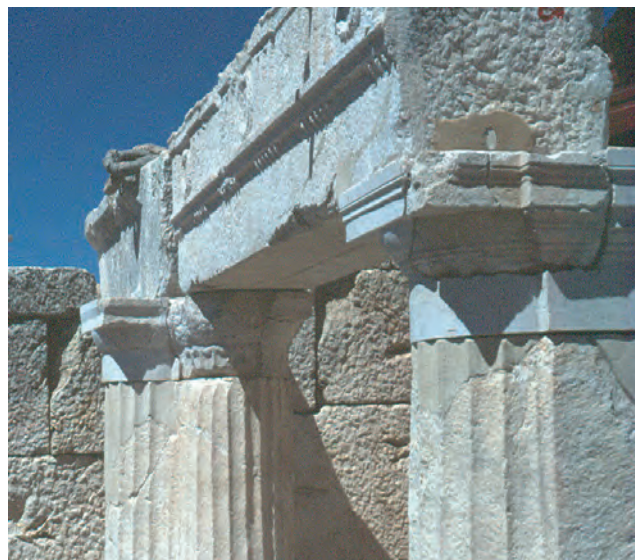
Figure 16 – Final surface carving of the integrations after their final anastylosis.

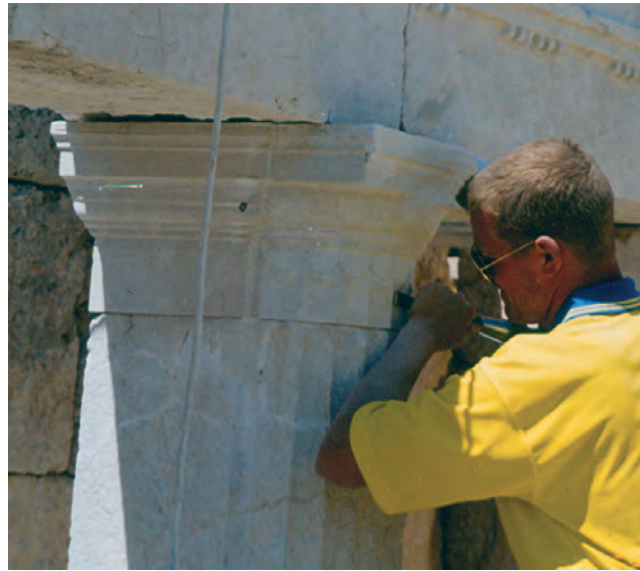
Figure 17 – First level of anastylosis, without introducing new carved elements.

The architectural investigation of the fountain house revealed that some complete stone blocks from the original structure were missing: wall blocks from the south and west wall, steps blocks from the entrance stair, cornices and capitals. Since the start of the project, the principle of minimum intervention was a fundamental aspect in our philosophy. Following this principle, it was clear that the missing blocks were only replaced by new elements when it was strictly necessary for the positioning of an existing one (Figure 17, Figure 18). (Patrício [et al.] 2000: 408)

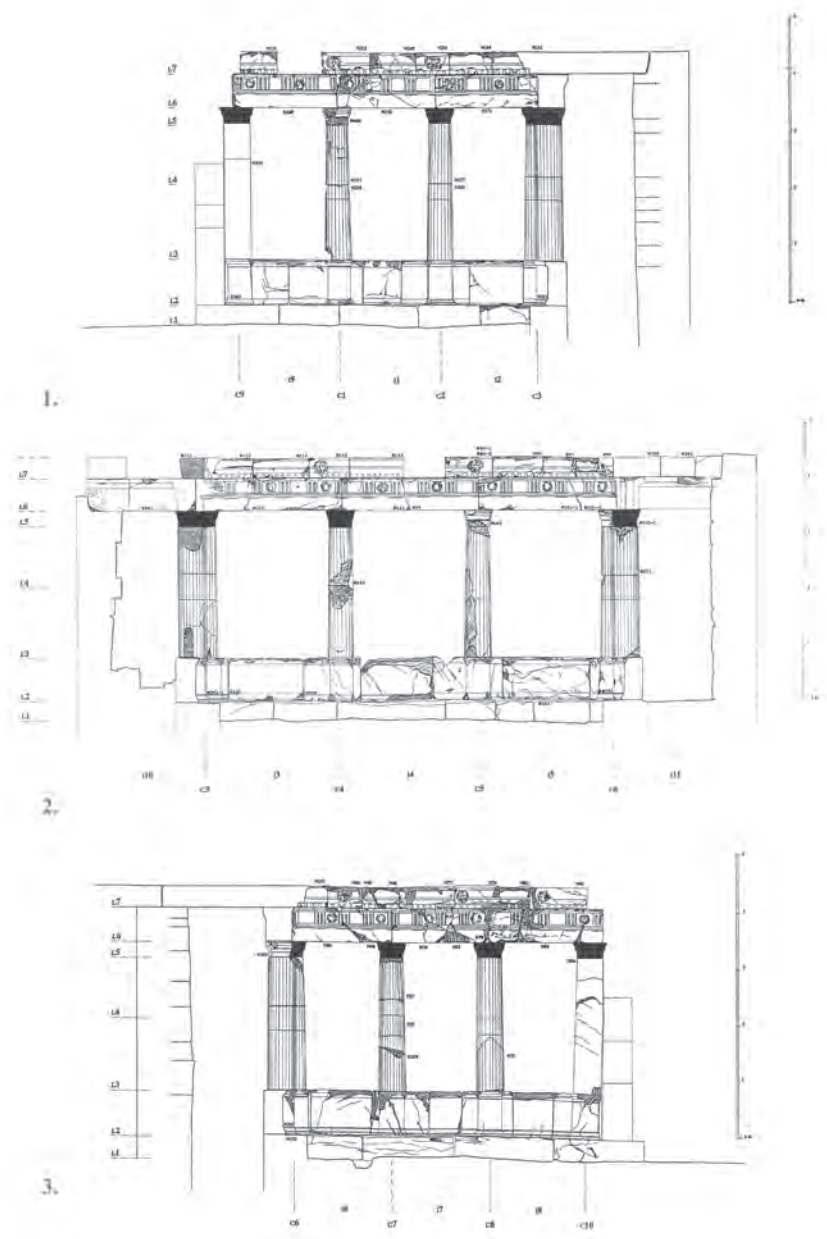
Figure 18 – Second level of anastylosis, introducing the new carved capital.
