**Cais das Colunas' pre-deconstruction (1997)  
diagnosis**

# CAIS DAS COLUNAS' PRE-DECONSTRUCTION (1997) DIAGNOSIS

## ABSTRACT

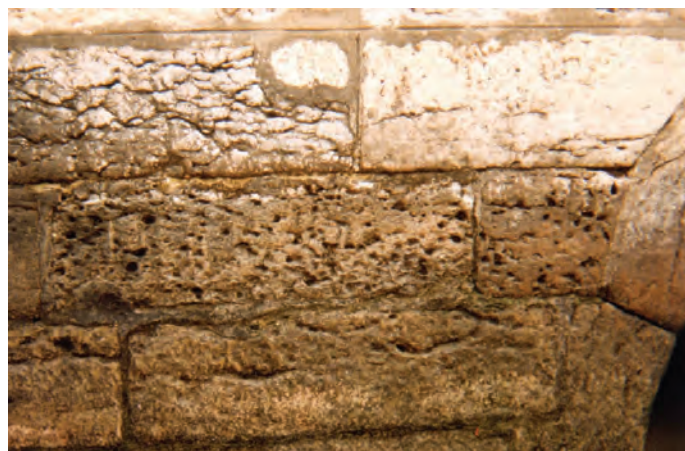
Figure 5 - Cais das Colunas, 1996. ACA®

The Map II (Figure 6) registers concretion, from biological origin, and variations of erosion, like erosion of edges and vertices, alveolization or alveolar weathering. The last ones occur due to the rocks' structural and compositional heterogeneity (Figure 5).

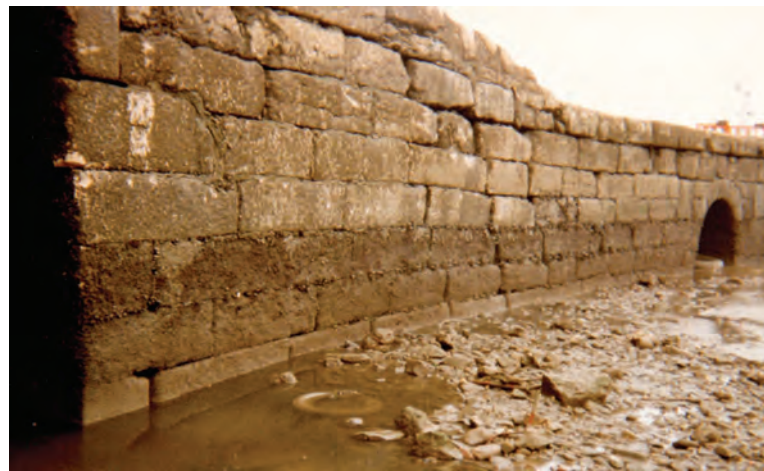
Figure 8 - Cais das Colunas, 1996. ACA®

The Map IV (Figure 10) registers chromic alteration of the surface of the rock (Figure 8), presence of oxidized metallic elements (Figure 9) and pathologies related with mortars. It were mapped the presence of cement mortar at the joints and the lack of mortar (Figure 8). The late one was detected especially at the area subjected to variation of the level of the river water due to tides.
