**Cais das Colunas' pre-deconstruction (1997)  
diagnosis**

# CAIS DAS COLUNAS' PRE-DECONSTRUCTION (1997) DIAGNOSIS

Alexandra de Carvalho Antunes

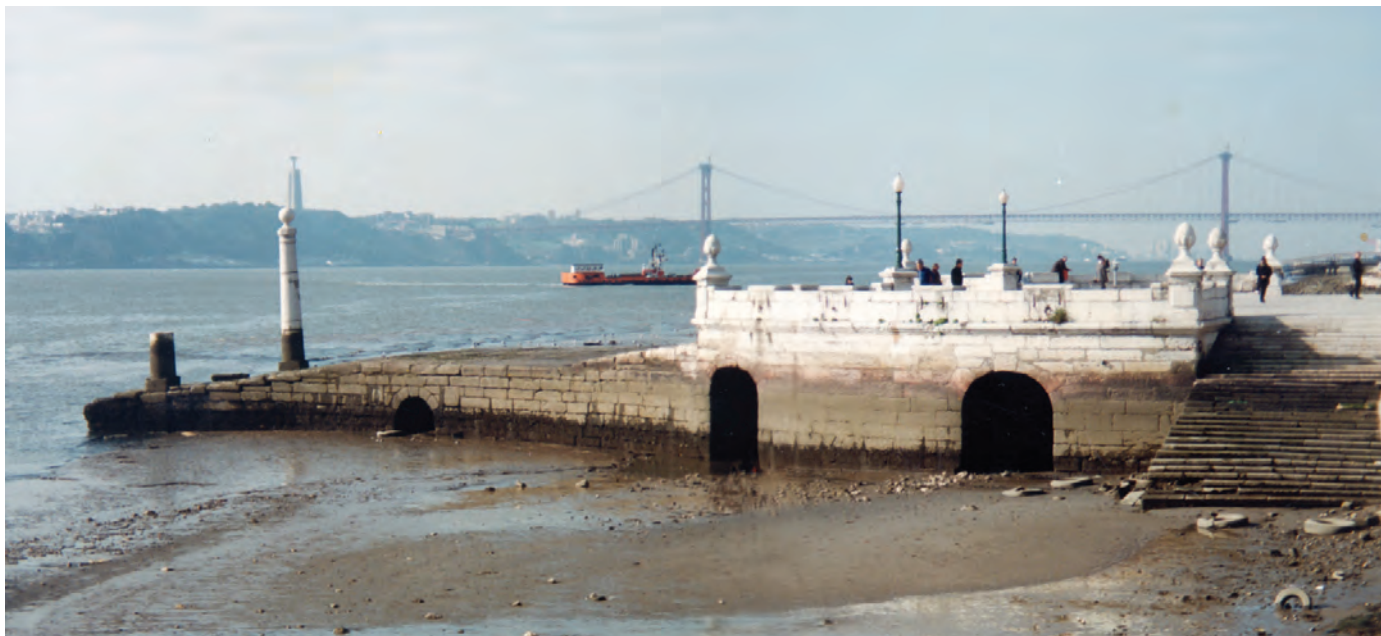
Figure 1 - Cais das Colunas, 1996. ACA®

The Cais das Colunas is a XVIIIth century limestone pier with two columns. It is located in the border of the Tagus River (Figure 1) and integrates the Terreiro do Paço (the Royal Square of the historical centre of Lisbon, National Heritage since 1910) and the historical downtown of Lisbon, also known as Baixa Pombalina (Figure 2). The quay, erected after the great Lisbon earthquake of 1755, is an historical place and tourist mark of the Portuguese capital.

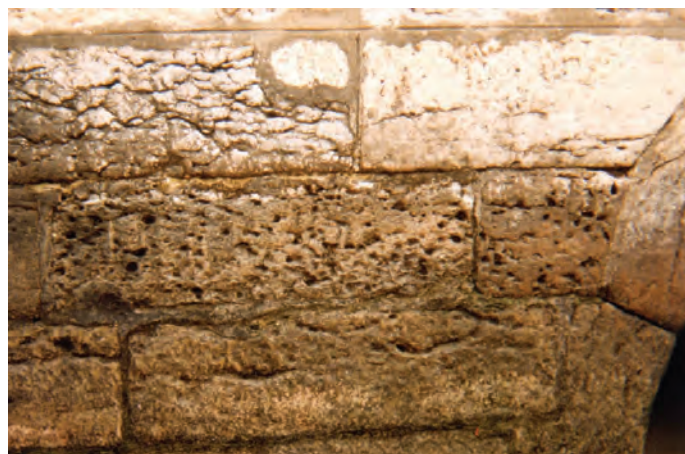
Figure 5 - Cais das Colunas, 1996. ACA®

The Map II (Figure 6) registers concretion, from biological origin, and variations of erosion, like erosion of edges and vertices, alveolization or alveolar weathering. The last ones occur due to the rocks' structural and compositional heterogeneity (Figure 5).

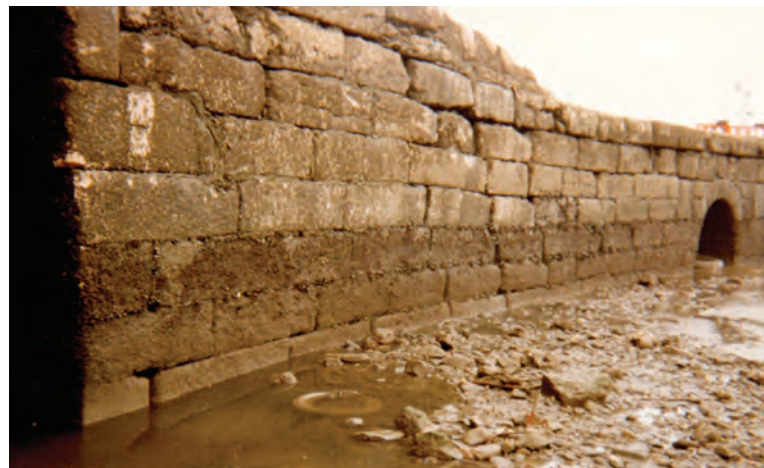
Figure 8 - Cais das Colunas, 1996. ACA®

The Map IV (Figure 10) registers chromic alteration of the surface of the rock (Figure 8), presence of oxidized metallic elements (Figure 9) and pathologies related with mortars. It were mapped the presence of cement mortar at the joints and the lack of mortar (Figure 8). The late one was detected especially at the area subjected to variation of the level of the river water due to tides.
