**Total heavy prefabrication: case study : Santo António dos Cavaleiros and Quinta do Morgado**

## **TOTAL HEAVY PREFABRICATION. CASE STUDY: SANTO ANTÓNIO DOS CAVALEIROS AND QUINTA DO MORGADO**

**Alberto Reaes Pinto**

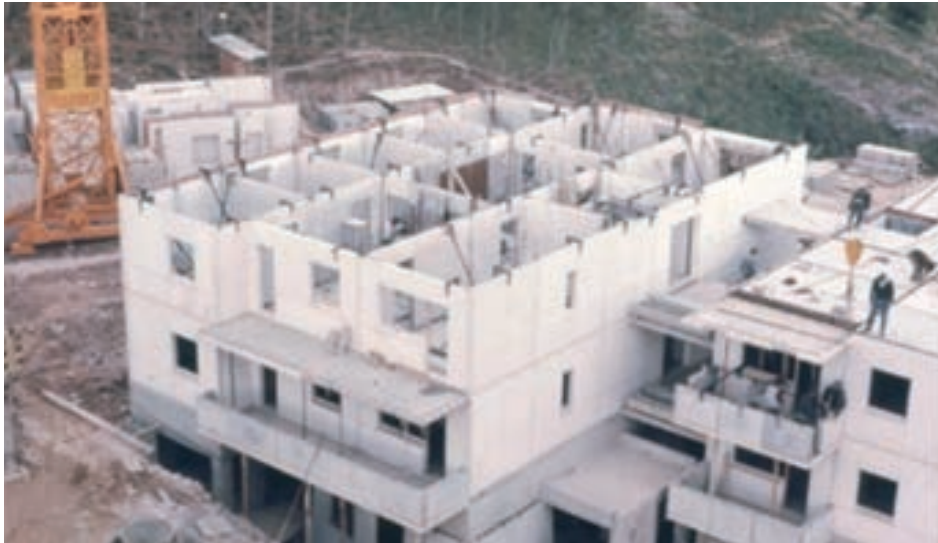
**Figure 1** - SAC - Assembly of the panels on site. Source: Reaes Pinto/ICESA 1968

Total Prefabrication in which all building components are produced in the factory and assembled on the building site, Figure 1.

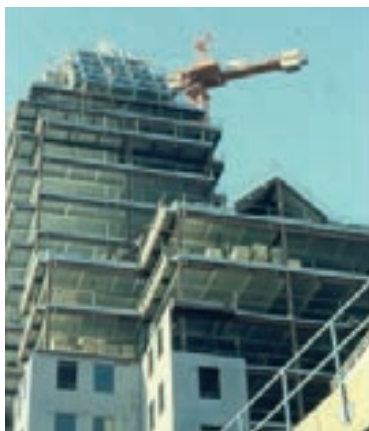
**Figure 2** - Partial prefabrication of exterior walls - conventional metallic structure. Souce: Reaes Pinto.

Prefabrication, whether total or partial, light or heavy, has been applied in plane, linear, plane-linear and tridimensional ways (Figure 2 - 5).

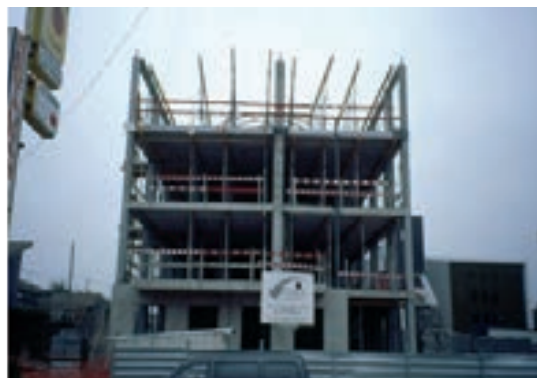
**Figure 3** - Plane - Linear prefabrication Pavicentro - Aveiro. Source: Reaes Pinto/1998.

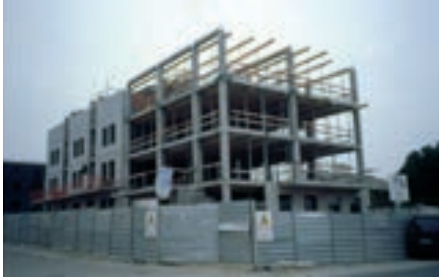
**Figure 4** - Plane - Linear Prefabrication Pavicentro - Aveiro. Source: Reaes Pinto/1998.

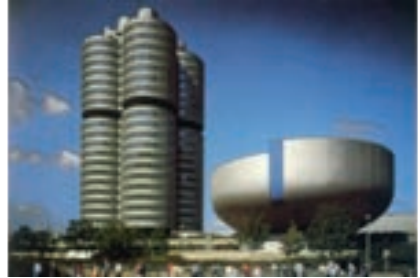
**Figure 5** - Lightweight Partial Prefabrication. Source: Reaes Pinto/1998.

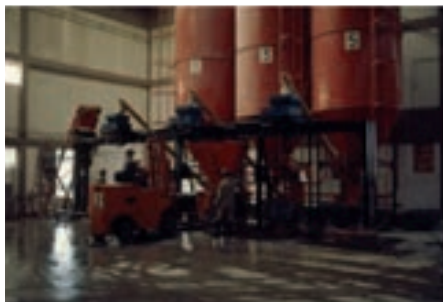
**Figure 18** - Automating concrete production station. Source: Reaes Pinto/ICESA

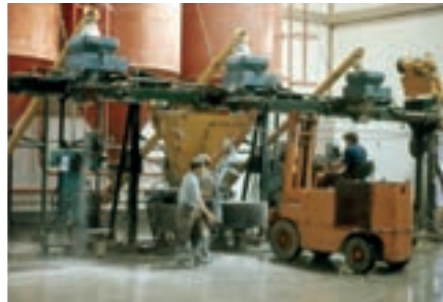
**Figure 19** - Automating gypsum production station. Source: Reaes Pinto/ICESA

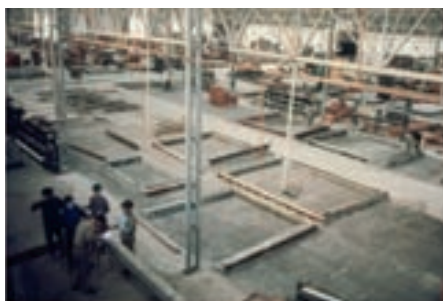
**Figure 20** - General view of the factory – metallic horizontal moulds. Source: Reaes Pinto/ICESA

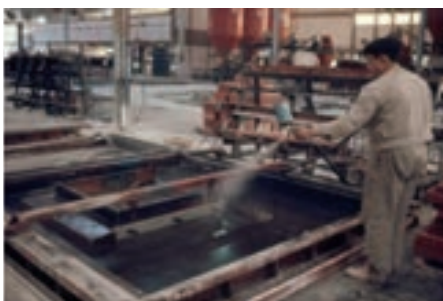
**Figure 21** - Lubrication of the bottom of the mould in order to facilitate demoulding.  
Source: Reaes Pinto/ICESA

- Too much oil used when freeing the panel from the mould (at the base of the mould) and on the lower interior surfaces in the plaster, not allowing the plaster any "breathing space", thus causing the drying of water in the materials which make up the panels to be more difficult. This also causes difficulty and a lack of adherence of paint when applied to the interior, and also provokes stains in the paintwork due to unequal adherence and absorption of the coats of paint over the plaster;

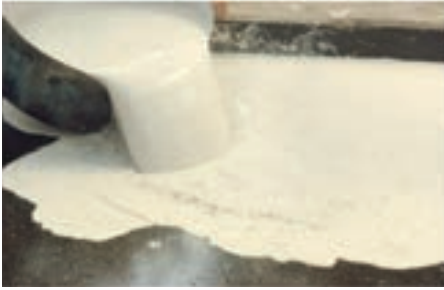
**Figure 22** - Gypsum Plaster leaking into the mould. Source: Reaes Pinto/ICESA

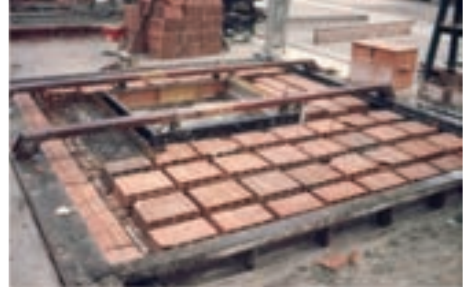
**Figure 23** - Reinforced Resistant Exterior Wall. Source: Reaes Pinto/ICESA 1966

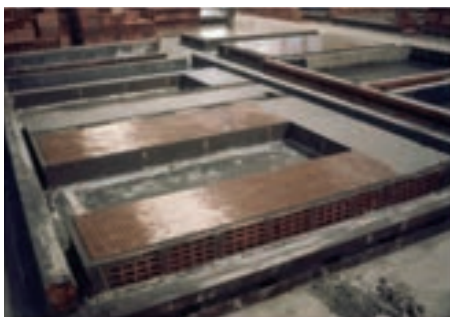
**Figure 26** - Resistente Interior Panels. Finishes with ceramic tiles for kitchens.  
Source: Reaes Pinto/ICESA 1968

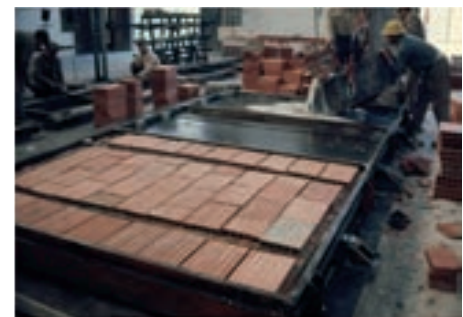
**Figure 27** - Partition Walls Panels. Source: Reaes Pinto/ICESA 1968

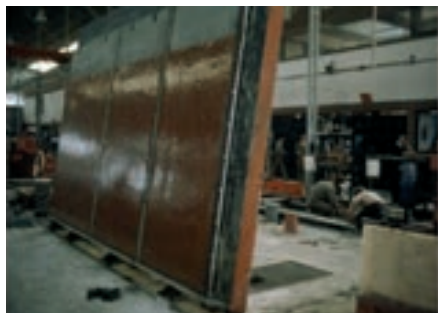
**Figure 28** - Hydraulic Panel manufacturing mould with a finished partition wall. Source: Reaes Pinto/ ICESA 1968

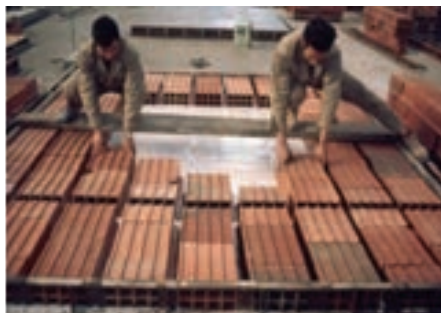
**Figure 29** - Slab Panels. Source: Reaes Pinto/ICESA 1968

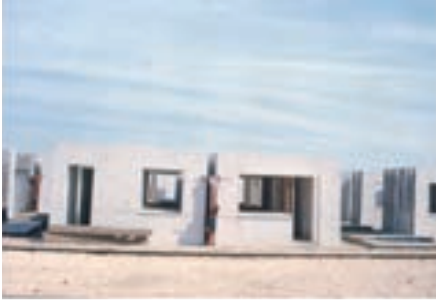
**Figure 34** - Storage Park Areas – Exterior Panels. Source: Reaes Pinto/ICESA 1968

- The absorption of humidity by the panels while still in the factory warehouse, due to prolonged storage (stacked on a sand base), this also gives rise to dirt stains and the degradation of the panel's covering (especially in the case of the plaster);

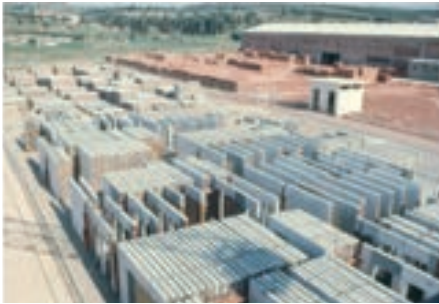
**Figure 36** - Storage Park Areas – Interior Panels. Source: Reaes Pinto/ICESA 1968

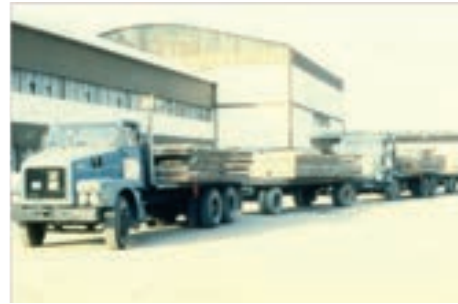
**Figure 37** - Transprot of Slab Panels. Source: Reaes Pinto/ICESA 1968

Bad loading of the panels for transportation, which could result in cracking or even breakage.

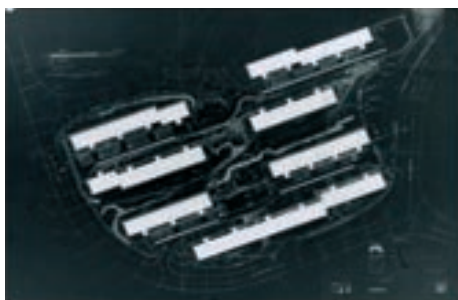
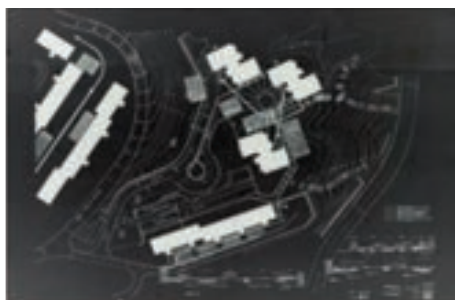
**Figure 40** - Layout in which the bands of buildings are parallel and spaced equally to allow assembly with the same crane on a single trajectory. Source: Reaes Pinto/ICESA

**Figure 41** - Implementation of high-rise buildings, without dismantling the cranes. Details of the external arrangements (streets). Source: Reaes Pinto/ICESA

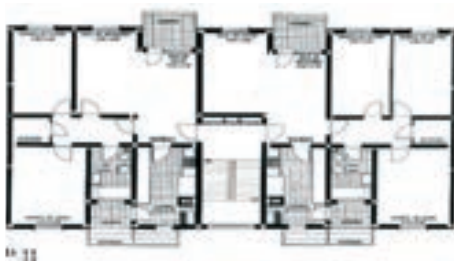
**Figure 42** - SAC - Category I3 - Typology T2/T3. Source: Reaes Pinto/ICESA

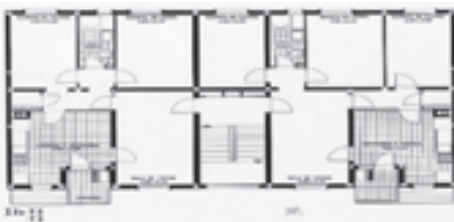
**Figure 44** - SAC - Category I2a - Typology T2/T3. Source: Reaes Pinto/ICESA

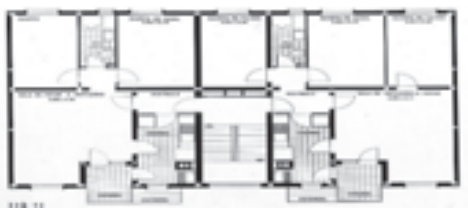
**Figure 45** - SAC - Category I2b - Typology T2/T3. Source: Reaes Pinto/ICESA

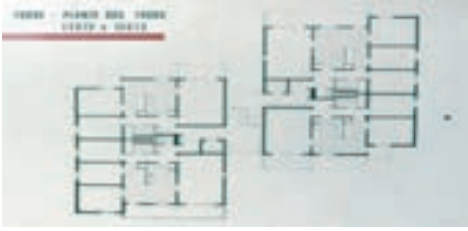
**Figure 47** - SAC - Category I2c, Tower 2 - Typology T2/T3. Source: Reaes Pinto/ICESA

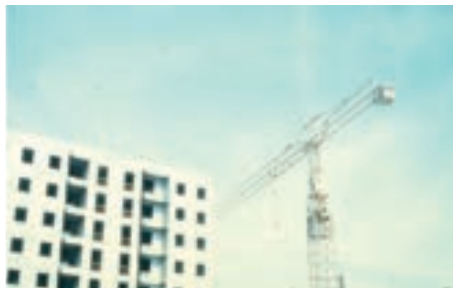
**Figure 49** - SAC - Assembly of the heavy panels on site. Source: Reaes Pinto/ICESA 1968

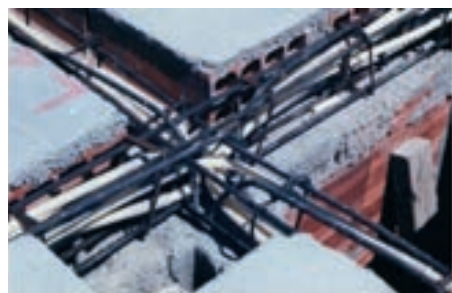
**Figure 50** - Network of electric tubes in the reinforced concrete belts, in the panels connections area (previous to the concreting). Source: Reaes Pinto/ICESA 1968

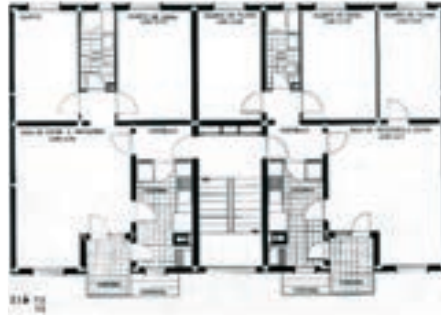
**Figure 59** - Quinta do Morgado. Horizontal building, Category I2, Tower – Typology. Source: Reaes Pinto/ICESA

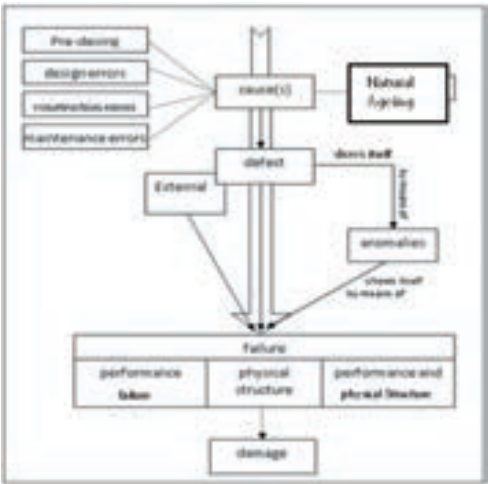
Figure 65 - The decay process. Source: CIB 1993

Finally, as a consequence of the failure, the (economic) damage appears at the end of the process (CIB 1993), (figure 65).

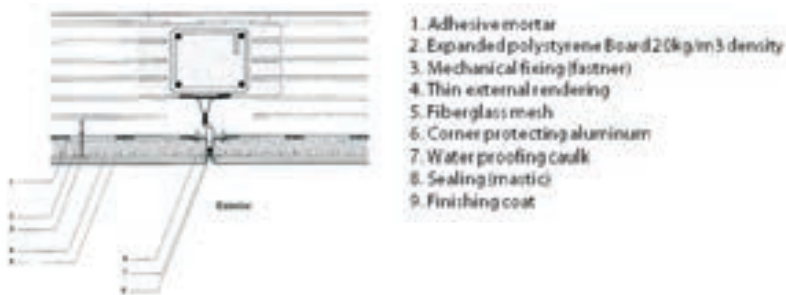
**Figure 69** - Final solution – Rehabilitation of the external walls of the SAC and QM buildings with an external insulation composite system with rendering. Source: Reaes Pinto.

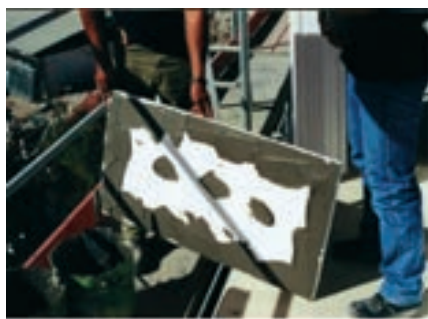
**Figura 71** - Building work in progress (Instituto Superior de Ciências Sociais e Políticas - Lisboa)  
- The insulation boards adhesive coat applied with points and bands. Source: Reaes Pinto, 2000.

The bonding is done with a mixed link mortar (synthetic mortar and cement) applied either at points, with bands or even in continuous application, when degraded walls have peelings with unlevellings over 5 mm (VIERO 2000).

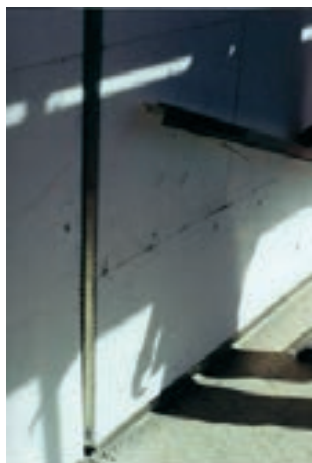
**Figura 72** - Building work in progress (Instituto Superior de Ciências Sociais e Políticas - Lisboa) - The insulation boards should be placed in rows with non-continuous vertical joints.  
Source: Reaes Pinto, 2000.

The insulation boards should be placed in rows; the vertical joints of the boards, however, should not be continuous, directly on the rigid support and bonded together with adhesive coat (a product used for bonding the insulation product to the wall substrate) and mechanical fixing devices.

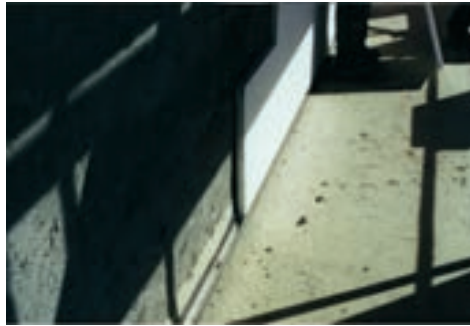
**Figura 73** - Building work in progress (Instituto Superior de Ciências Sociais e Políticas – Lisboa)  
Special fitting profiles to allow an adequate fitting of the pieces and the better continuity. Source: Reaes Pinto, 2000.

The design of the insulating material should have a fitting profile at each end so as to allow an adequate fitting of the pieces and better continuity.

The system should include special fittings (base profiles, corner profiles, etc.), to connect them to adjacent building structures (apertures, corners, parapets, etc).

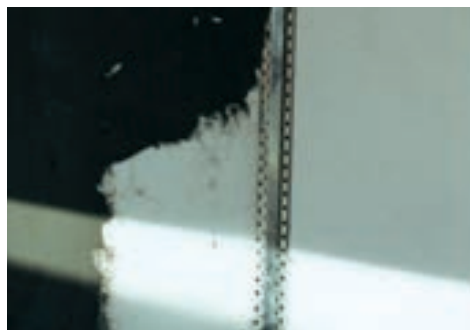
**Figure 74** - Building work in progress (Instituto Superior de Ciências Sociais e Políticas – Lisboa)  
The rendering system is constituted by two layers reinforced with fibreglass mesh. Source: Reaes Pinto, 2000.

The rendering system is constituted by one or more layers reinforced with fiberglass mesh applied onto the thermal insulation panels. All the coats are applied on the outer face of the insulation product together with the reinforcement, (ETA Guideline on ETICS) (EU 1999). This rendering is constituted by a first layer - base coat - of mixed link, similar to the adhesive coat mortar, applied directly over the insulating product. Over this still fresh covering layer, the base coat, one would directly apply a reinforcement layer (fiberglass mesh), which would provide most of the mechanical properties of the rendering.
