**The restoration of the Hellenistic fountain of
Sagalassos in Turkey**

THE RESTORATION OF THE HELLENISTIC FOUNTAIN OF SAGALASSOS IN TURKEY

Teresa Cristina Patrício

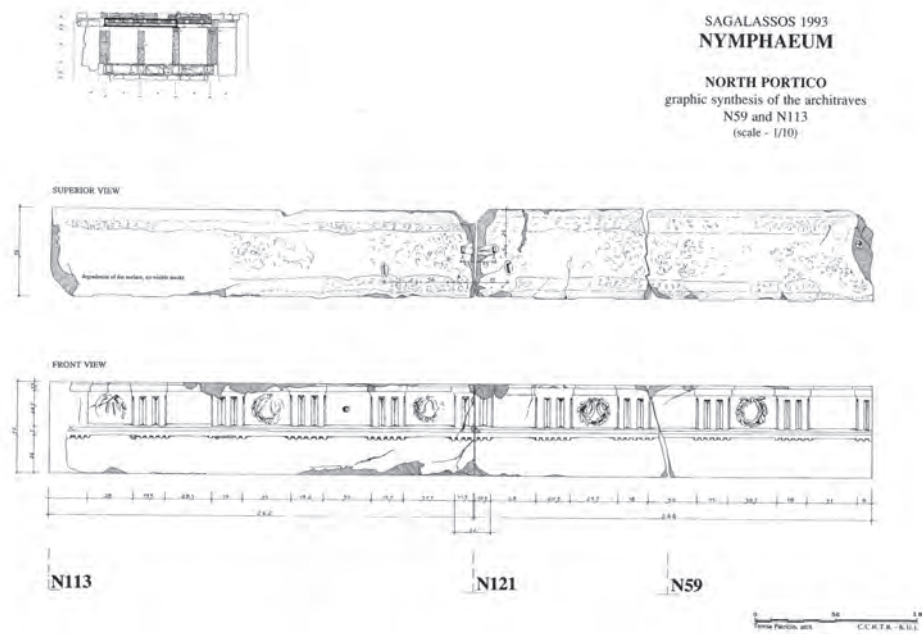
Figure 6 - Graphic synthesis of two architraves of the North Portico.
